**Region 6 Compliance Assurance and Enforcement Division
INSPECTION REPORT**

Inspection Date(s):	05/04/2016		
Media:	Wastewater		
Regulatory Program(s)	Environmental Protection Agency		
Company Name:	Ruidoso/ Ruidoso Down		
Facility Name:	Village of Ruidoso Wastewater Treatment		
Facility Physical Location:	26715 U.S. 70		
(city, state, zip code)	Ruidoso Downs, NM 88346		
Mailing address:	313 Cree Meadows Drive		
(city, state, zip code)	Ruidoso, NM 88345		
County/Parish:	Lincoln County		
Facility Contact:	Isaac Garcia	Chief Plan Operator	
	IsaacGarcia@ruidoso-nm.gov		
FRS Number:	110010721950		
Identification/Permit Number:	NM0029165		
NAICS:	N/A		
SIC:	4952		
Personnel participating in inspection:			
Mitty Mohon	EPA Region 6 – Dallas	Environmental Scientist	214-665-6497
David Long	EPA Region 6 – Houston	Environmental Scientist	214-665-7323
Jennifer Foote	State of New Mexico Environmental Depart	Municipal Team Leader	505-827-0596
Isaac Garcia	Village of Ruidoso	Chief Plant Operator	505-378-8417

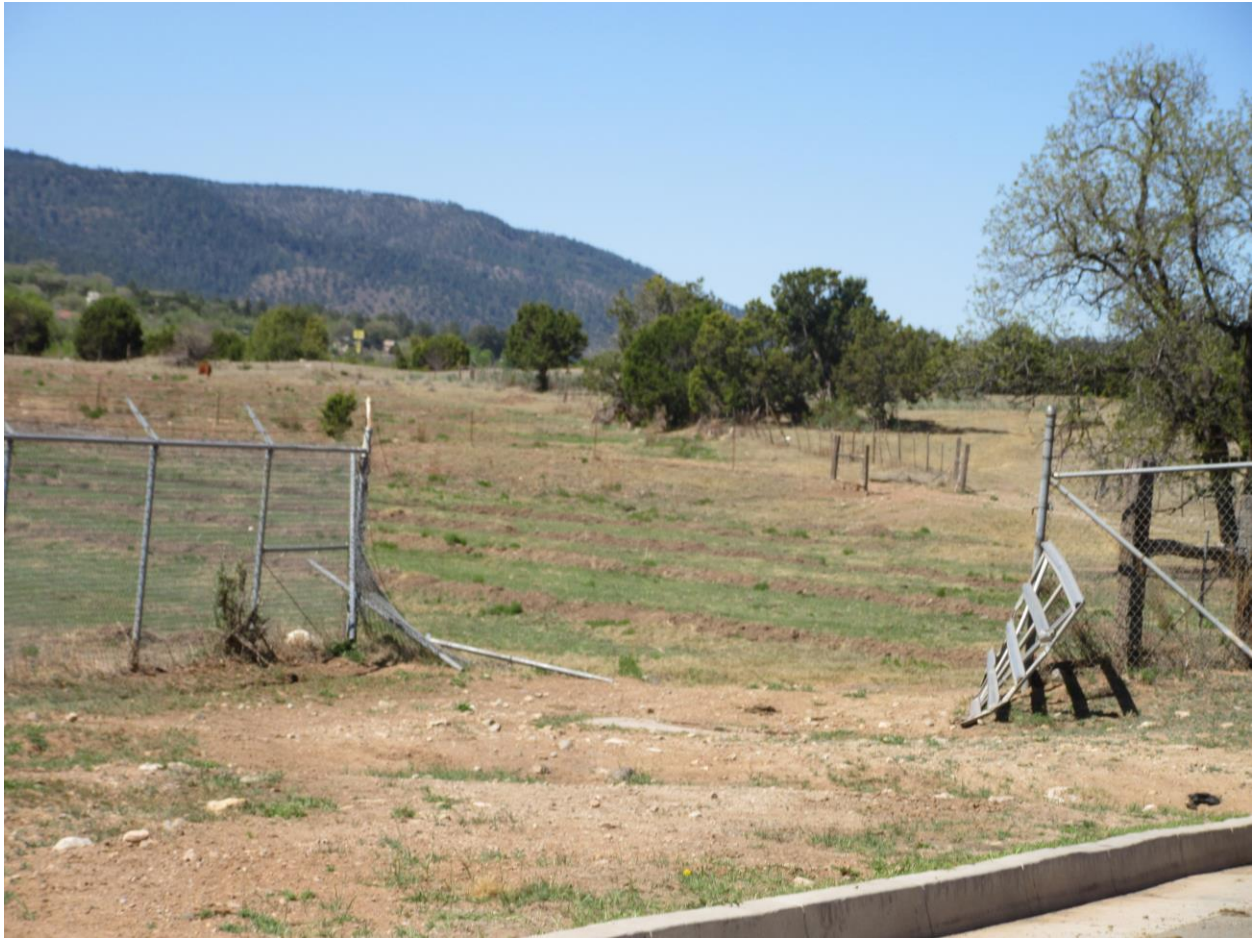
Photo File Name: Ruidoso Fencing_001

There were only a few observations from the walkthrough of the plant. The fence/gate at the southwest corner of the plant was open and damaged. There was minor property damage due to cows getting into the plant. Since 2011, the plant built a new infrastructure but the old plant was not demolished. The new infrastructure already has noticeable cracks and signs of corrosion. The equalization basins from the old plant are now being utilized as holding tanks in case of an emergency. All power to the old plant equipment has been removed. Sludge was tracked out of the sludge holding areas most likely due to cows. In the equipment room, staff acknowledged that chlorine was utilized to clean the equipment onsite. After the UV disinfection system, the permit requires to take samples at outfall 001. The effluent sampler did not have a thermometer inside to ensure it was at the proper temperature.

Description: Damaged fencing and gate (facing southwest).

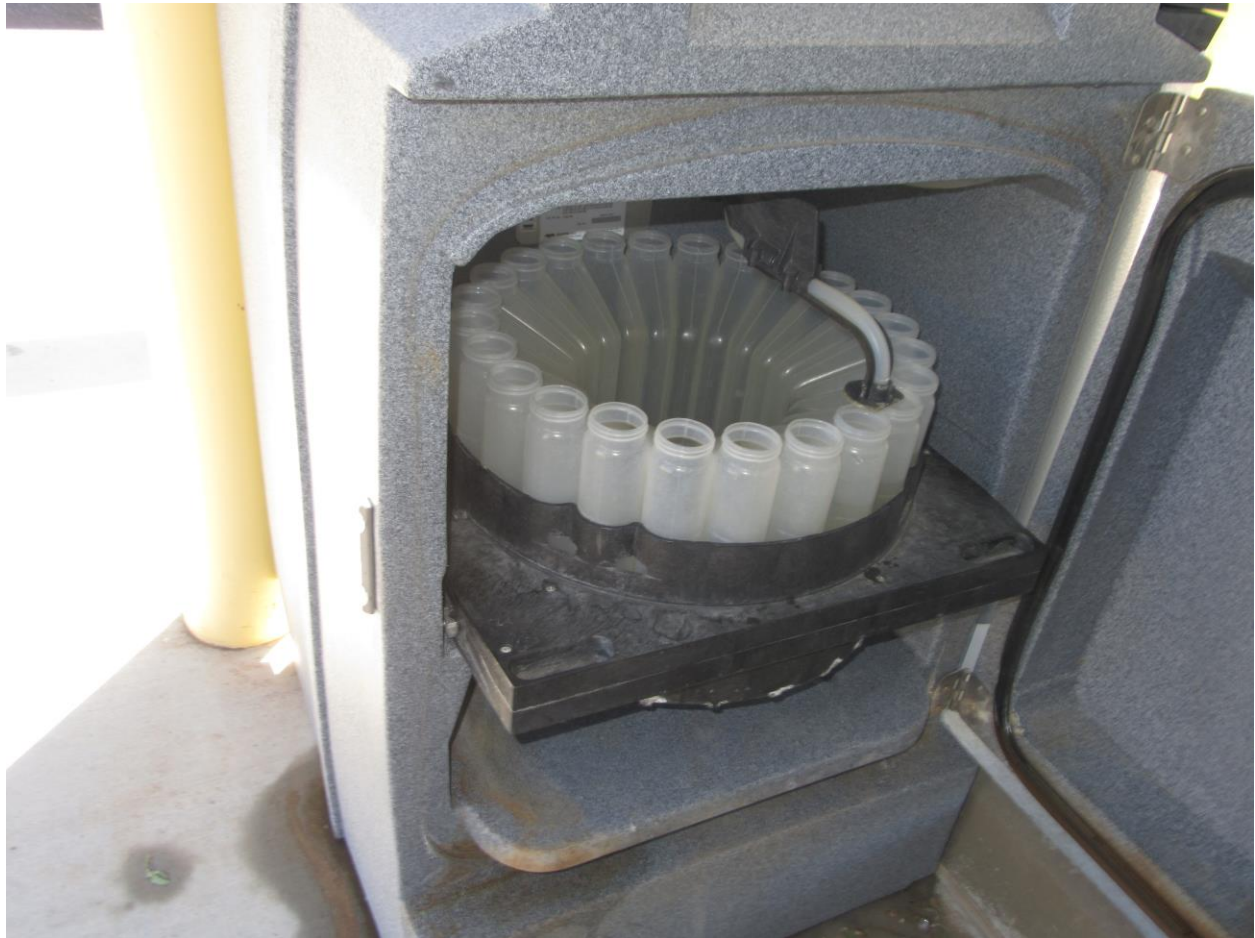
Photo File Name: Ruidoso Sampler_002

- No thermometer was found in the effluent sampler and no calibration tag was located on a thermometer in the lab incubator.
- The facility is using chlorine to clean their equipment that is then being pump to the headworks of the treatment process.

Description: Effluent Sampler near the UV Disinfection system. The thermometer was missing from this sampler during inspection.
